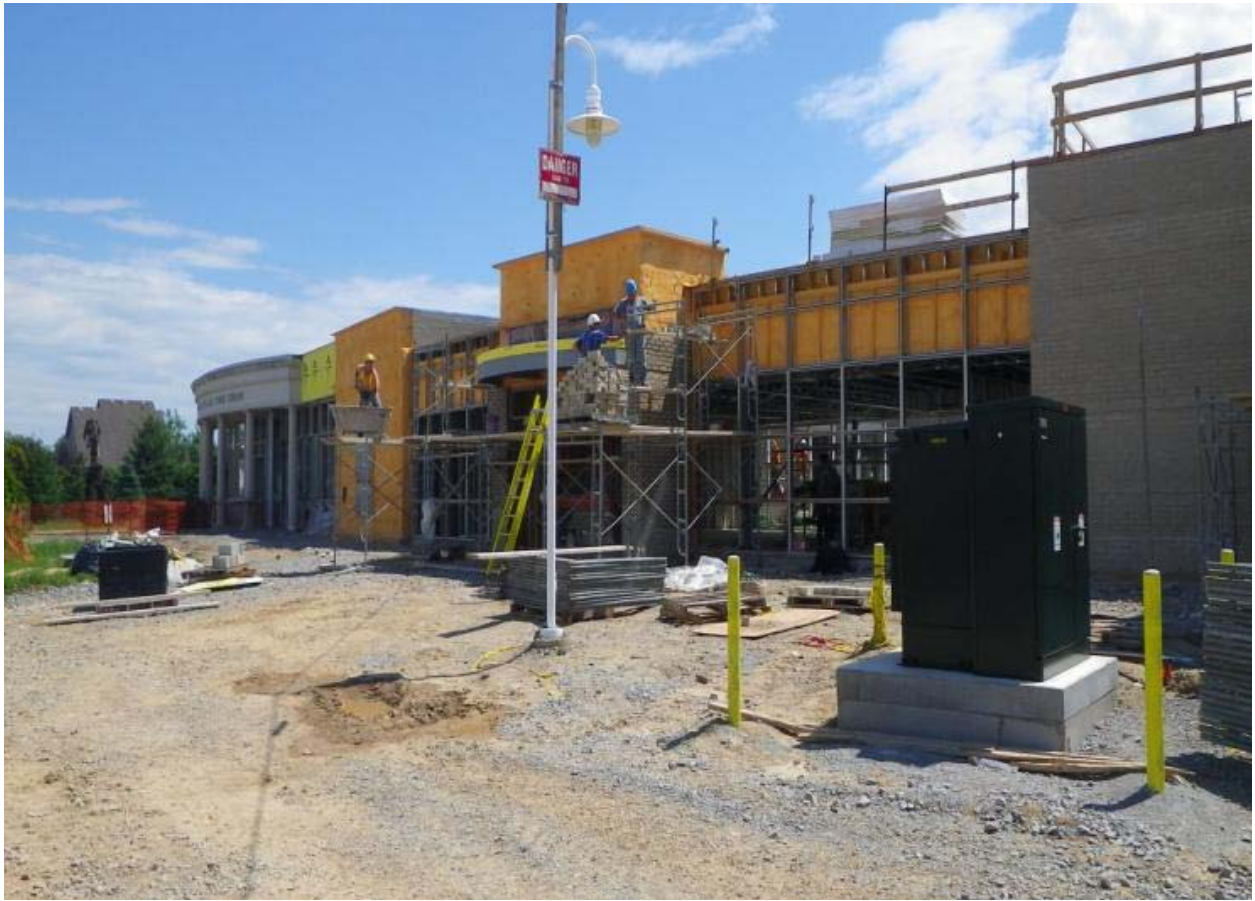
Window framing and masonry work proceeding at building entrance.
